USAARL REPORT NO. 77-7

AEROMEDICAL EVALUATION OF UH-1 INTERNAL ADVANCED PERSONNEL RESCUE HOISTS
WESTERN GEAR CORPORATION HOIST MODELS 42277R1 AND 42305R1
BREEZE CORPORATION HOIST ECP-720 MODIFICATION

February 1977

US Army Aeromedical Research Laboratory
Fort Rucker, Alabama 36362

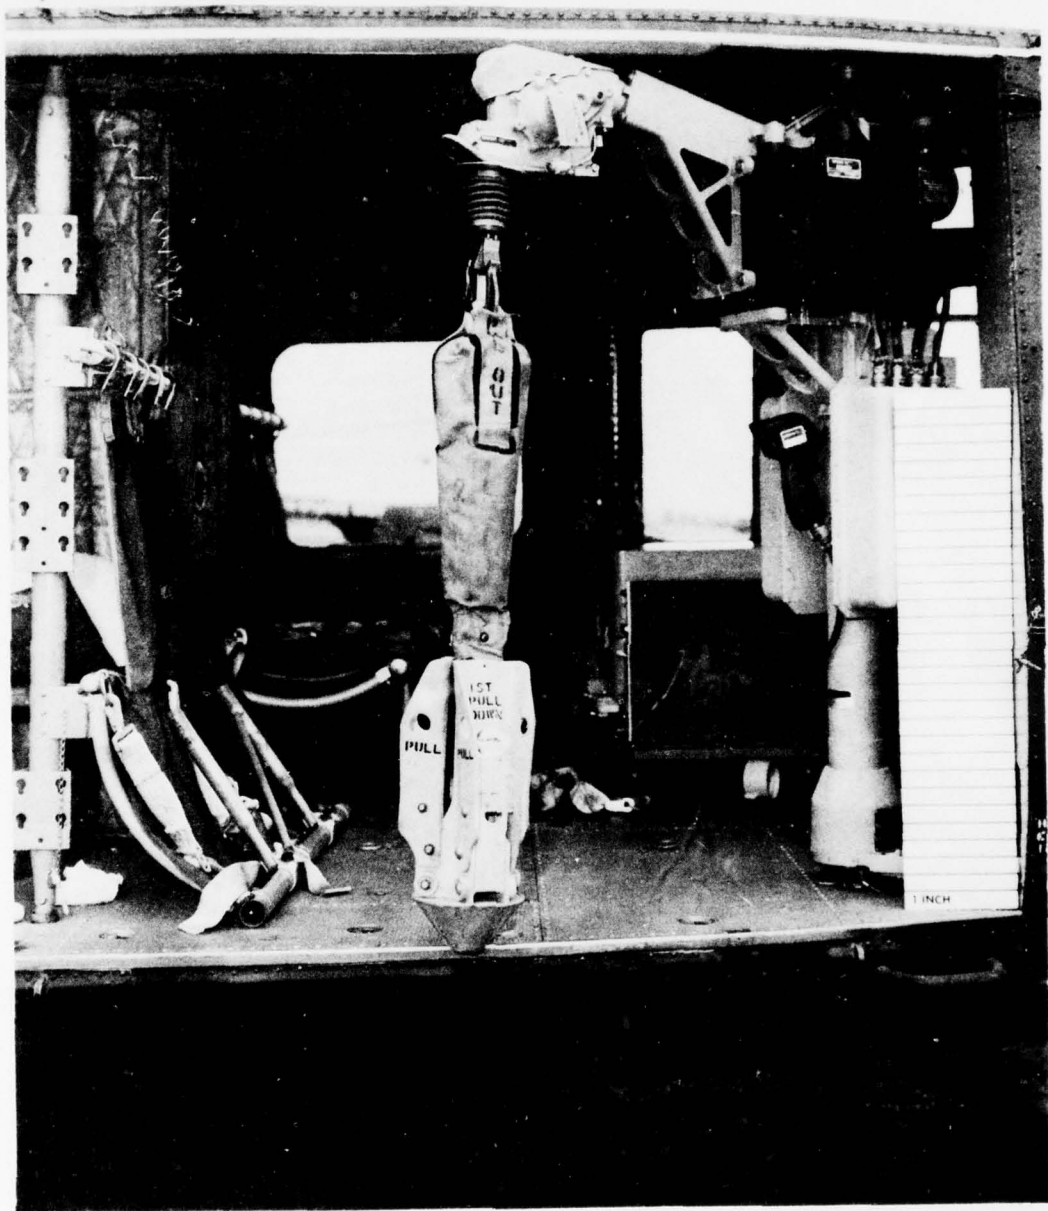
PHOTO A

Photographs A, C, E, and G illustrate the WGH hoist effect on entrance door and cabin space compared to the Breeze ECP-720 hoist photographs B, D, and F. Conservation of entrance door space, as well as absence of actuator base plate, is noted in photographs of WGH.

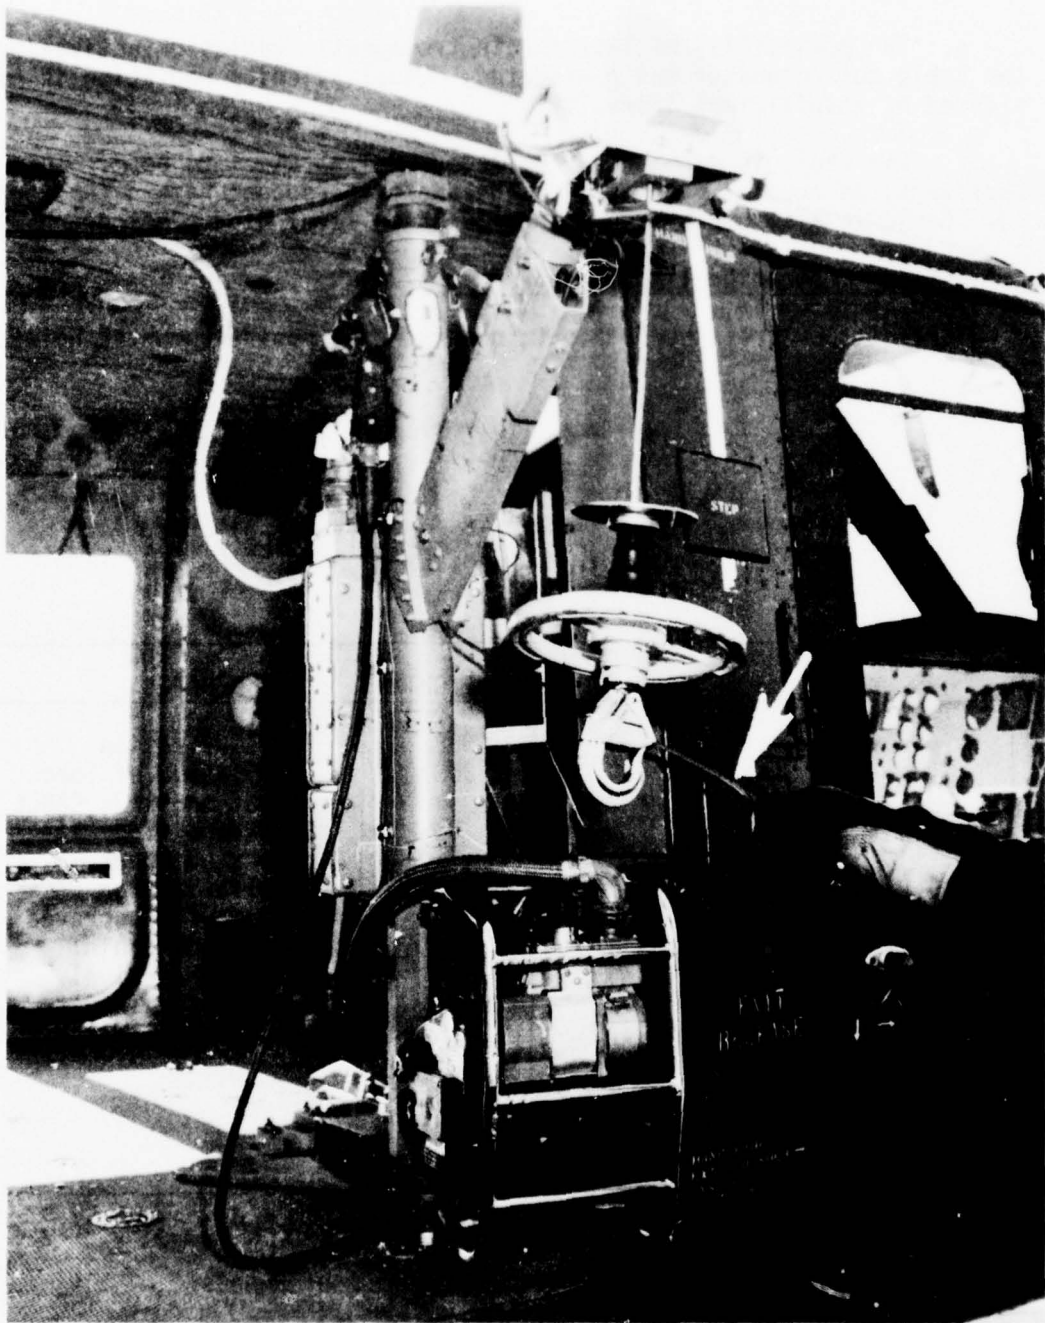
PHOTO 1

d. The cable is exposed during the travel parallel to boom. This represents an area of potential damage and/or personnel hazard (Photograph I). Cable is also capable of being fouled on level wind (Photograph J).
